DRAFT
FINDING OF NO SIGNIFICANT IMPACT
for the
PUBLIC LAW 84-99 RECLAMATION DISTRICT 765, CALIFORNIA

Environmental Assessment/Initial Study

**Public Law 84-99
Reclamation District 765
Sacramento River
Yolo County, California**

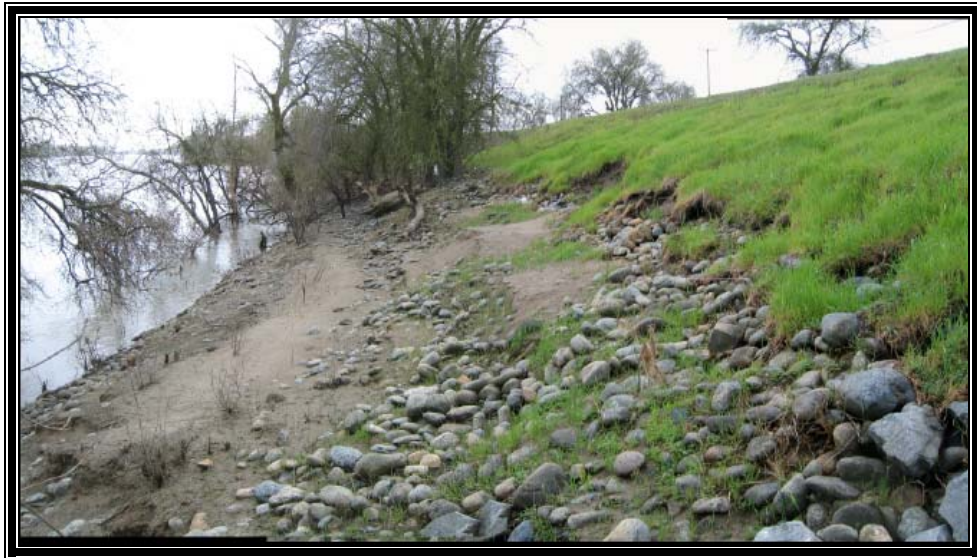
Plate 2 – Damage on Sacramento River, Site 002

Sacramento River, West Bank Levee, Site No. 002. Wave wash and toe erosion into the standard levee cross section occurred along a 120 foot reach of the Sacramento River, West Bank Levee. Erosion reached 2 to 3 feet in height. Existing riprap was lost or damaged (see Plate 2). Restoration of the levee is considered an emergency since the stability of the embankment is reduced and damages may be exacerbated during the next heavy rain event.

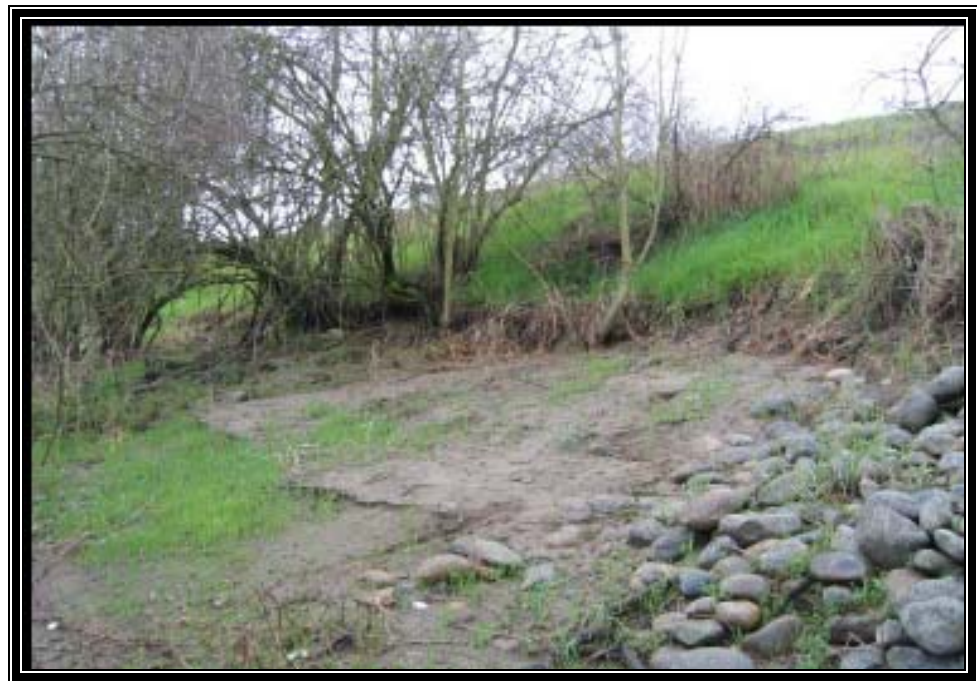
Plate 3 – Damage on Sacramento River, Site 003

Sacramento River, West Bank Levee, Site No. 003. Wave wash and toe erosion into the standard levee cross section occurred along a 500 foot reach of the Sacramento River, West Bank Levee. Erosion reached 3 feet in height. Existing riprap was lost or damaged by the flood events (see Plate 3). Restoration of the levee is considered an emergency since the stability of the embankment is reduced and damages may be exacerbated during the next heavy rain event.

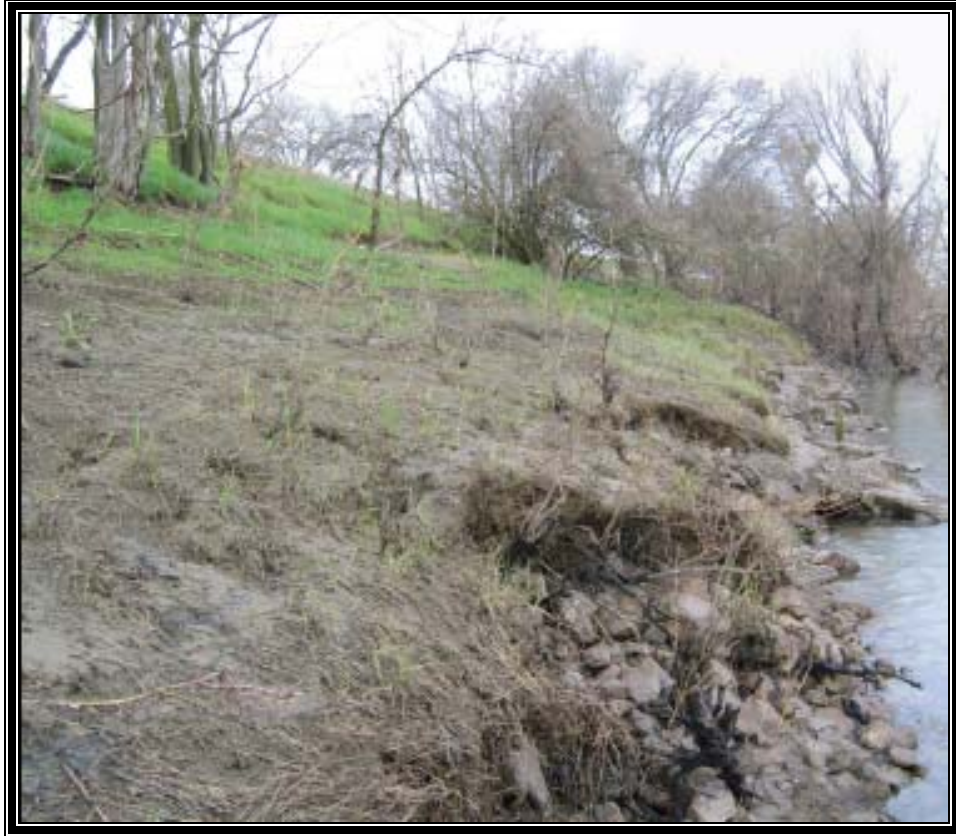
Plate 4 – Damage on Sacramento River, Site 004

Sacramento River, West Bank Levee, Site No. 004. Wave wash and toe erosion into the standard levee cross section occurred along a 130 foot reach of the Sacramento River, West Bank Levee. Erosion reached 2 to 3 feet into the levee slope. Existing riprap was lost or damaged by the flood events (see Plate 4). Restoration of the levee is considered an emergency since the stability of the embankment is reduced and damages may be exacerbated during the next flood event.

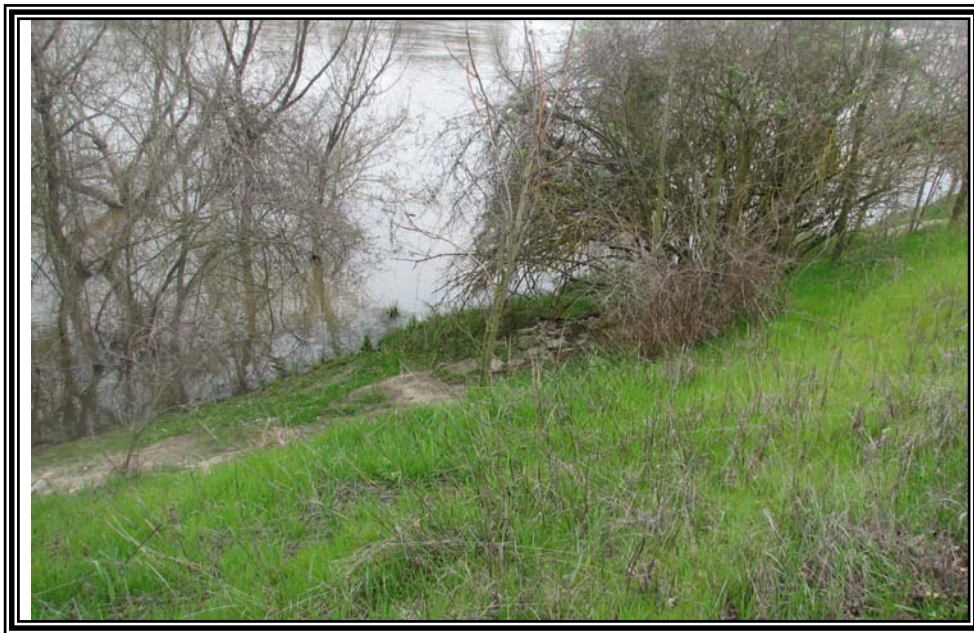
Plate 5 – Damage on Sacramento River, Site 005

Sacramento River, West Bank Levee, Site No. 005. Wave wash erosion and toe erosion into the standard levee cross section occurred along a 90 foot reach of the Sacramento River, West Bank Levee. Erosion reached up to 5 feet into the levee slope. Existing riprap was lost or damaged by the flood events (see Plate 5). Restoration of the levee is considered an emergency since the stability of the embankment is reduced and damages may be exacerbated during the next flood event.

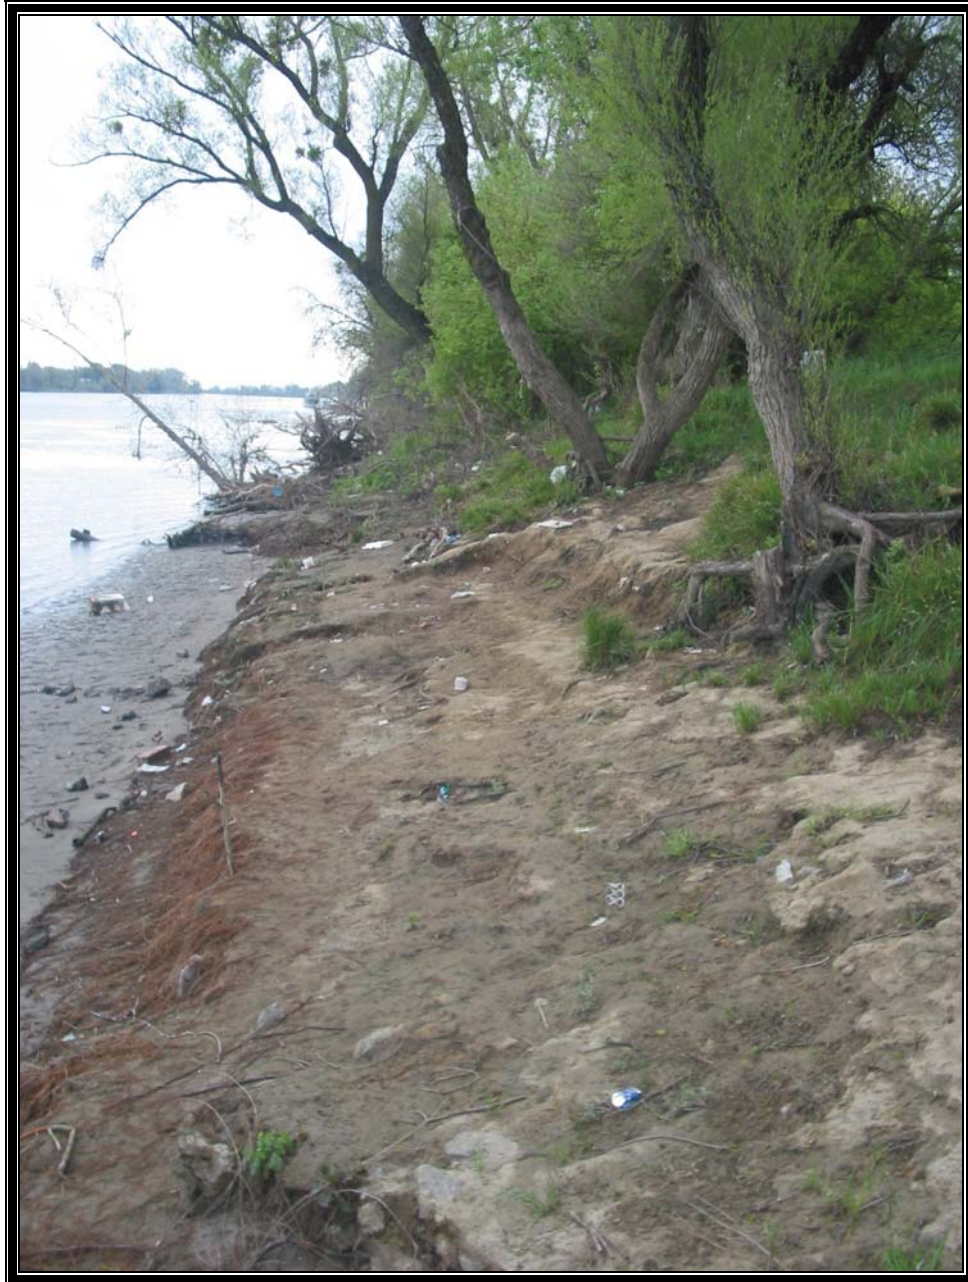
Plate 6 – Damage on Sacramento River, Site 006

Sacramento River, West Bank Levee, Site No. 006. Wave wash and toe erosion into the standard levee cross section occurred along a 175 foot reach of the Sacramento River, West Bank Levee. Erosion reached up to 5 feet into the levee slope. Existing rock protection of the waterside slope was lost or damaged (see Plate 6). Restoration of the levee is considered an emergency since the stability of the embankment is reduced and damages may be exacerbated during subsequent flood events.
